**Supplemental Information & Instructions
for
TACHO REDUCTION GEARBOX
MG T SERIES**

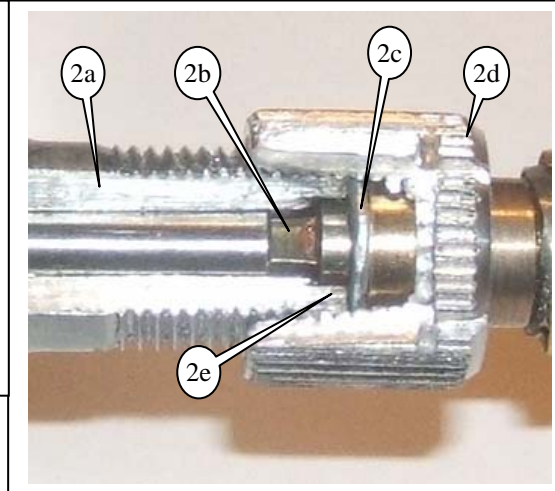
Found only with the OE style cable. The cable manufacturer currently uses a circlip (1a) to retain the inner cable in the housing. When attached to the tach reduction gearbox (2a), the circlip (2c) bottoms out against the end of the tach reduction gearbox (2e) when the nut on the cable (2d) is tightened. The cable is locked in place and it cannot rotate.
